**BioSqueeze**  
SEALED WELL

## Case Study 051

# BioSqueeze® Seals Casing Leak

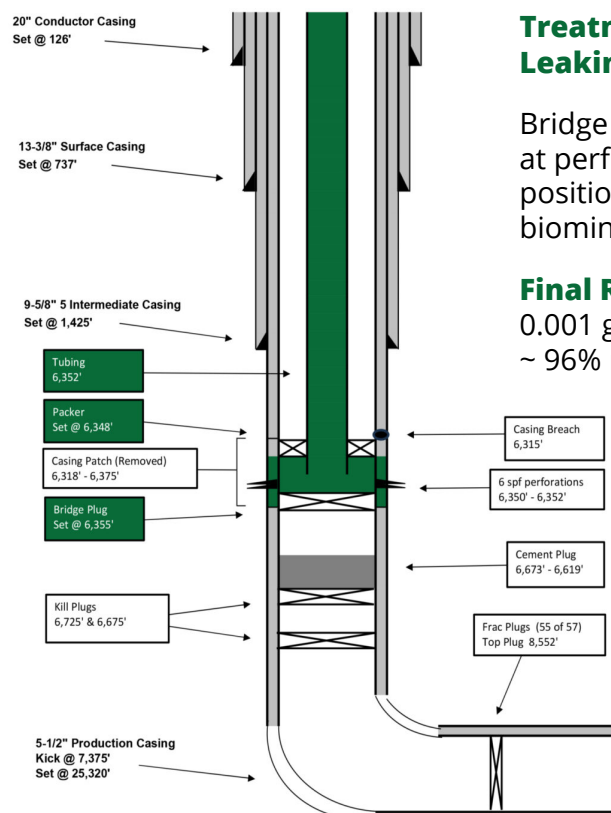
### Treatment One: Leaking Perforations

BioSqueeze Inc. was contracted to restore mechanical integrity on a Marcellus Shale well undergoing post-frac drillout to bring the asset online. On stage 56 of 57 pressure rapidly decreased and a subsequent camera run revealed the patch was compromised. The patch was then removed, and resin was squeezed into the perforations, but they continued to leak at which point BioSqueeze Inc. was brought in to address the issue.

Bridge plug set, tubing hung at perforated interval, packer positioned. Injected 1.67 gallons biomineralizing fluid.

0.001 gpm @ 1,608 psi  
~ 96% reduction

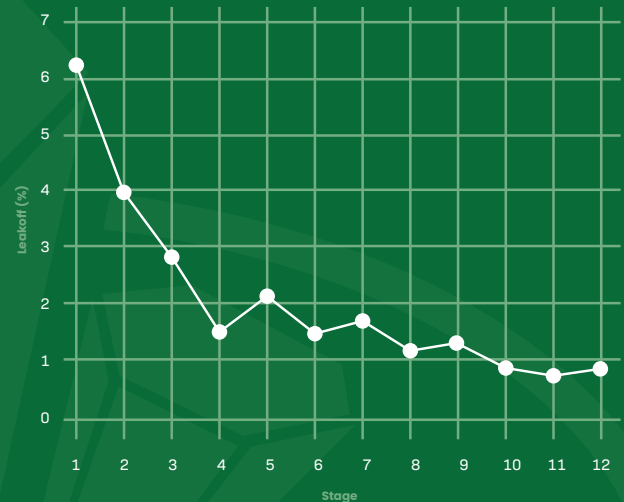
Treatment Two: Casing Breach

Initial Rate - 79 psi/5 min ~7.9% (at 1,000 psi)  
Final Rate - 13 psi/15 min ~0.81% (at 1,600 psi)

✓ The well was held static at pressure for 10 hours without any further loss, allowing the well to be completed and put into production.
